STREAM CHANNEL EVOLUTION OF LITTLE SALT CREEK AND NORTH BRANCH WEST PAPILLION CREEK, EASTERN NEBRASKA

Eddy J. Langendoen and Andrew Simon
United States Department of Agriculture
Agricultural Research Service
National Sedimentation Laboratory
P.O. Box 1157
Oxford, MS 38655

Lower Platte South Natural Resources
District, Lincoln, Nebraska
Papio-Missouri Natural Resources
District, Omaha, Nebraska

February 2000

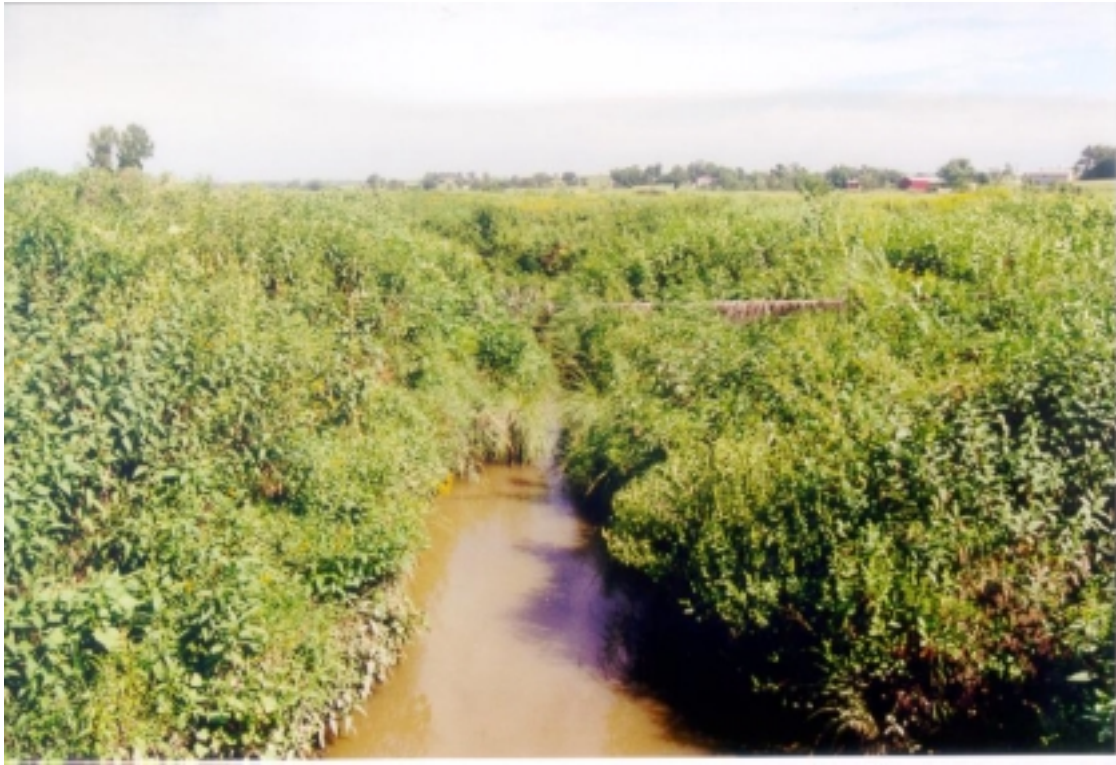
Figure 1.3 View of Little Salt Creek and wetlands upstream of Raymond Road.

The Little Salt Creek is a tributary of Salt Creek and drains approximately 46.5 mi² (119 km²). The average channel slope along the modeling reach is 0.0015. Saline wetlands in the Salt Creek basin have diminished from 16,000 acres originally to approximately 1,200 acres (Lower Platte South Natural Resources District, 1999). They hold a diversity of wildlife and contain rare plant communities. A saline wetland north of Raymond Road (Figure 1.3) is endangered by channel incision, which may lead to draining of the wetland. Channel incision may also lead to additional streambank failures and loss of wetland area (Figure 1.4).

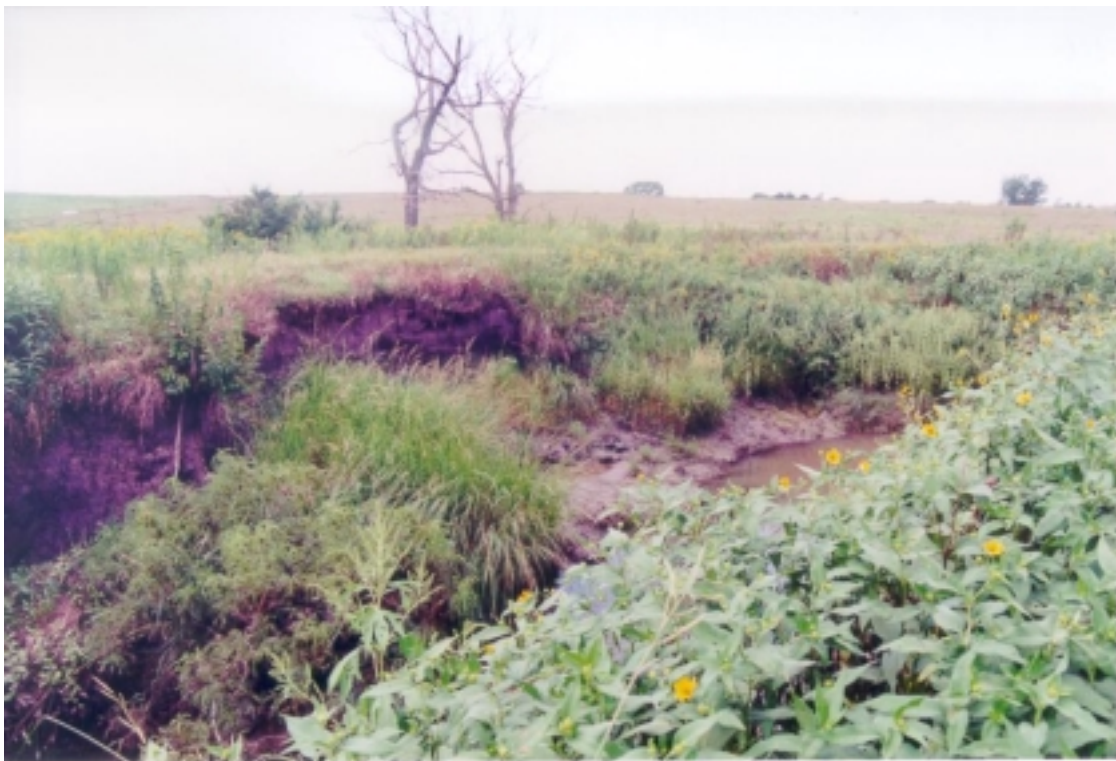
Figure 1.4 Streambank failure along Little Salt Creek north of Raymond Road.

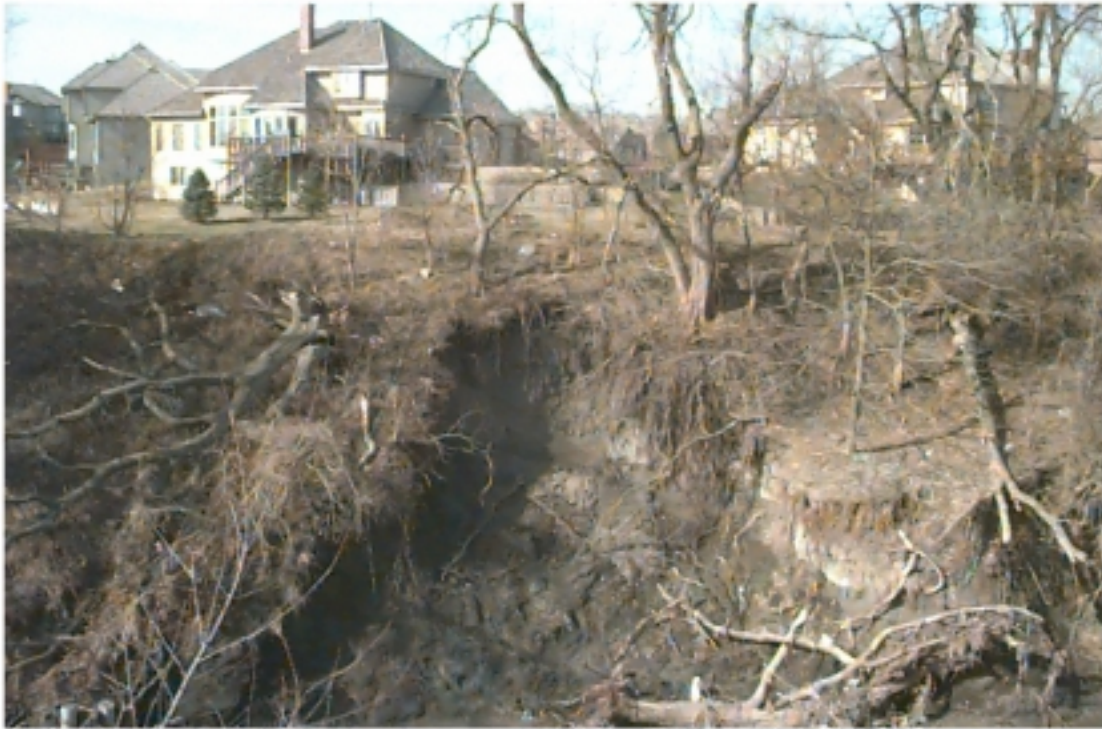
Figure 1.5 Urbanization and streambank failure along the West Papillion Creek between Dodge and Pacific Streets.

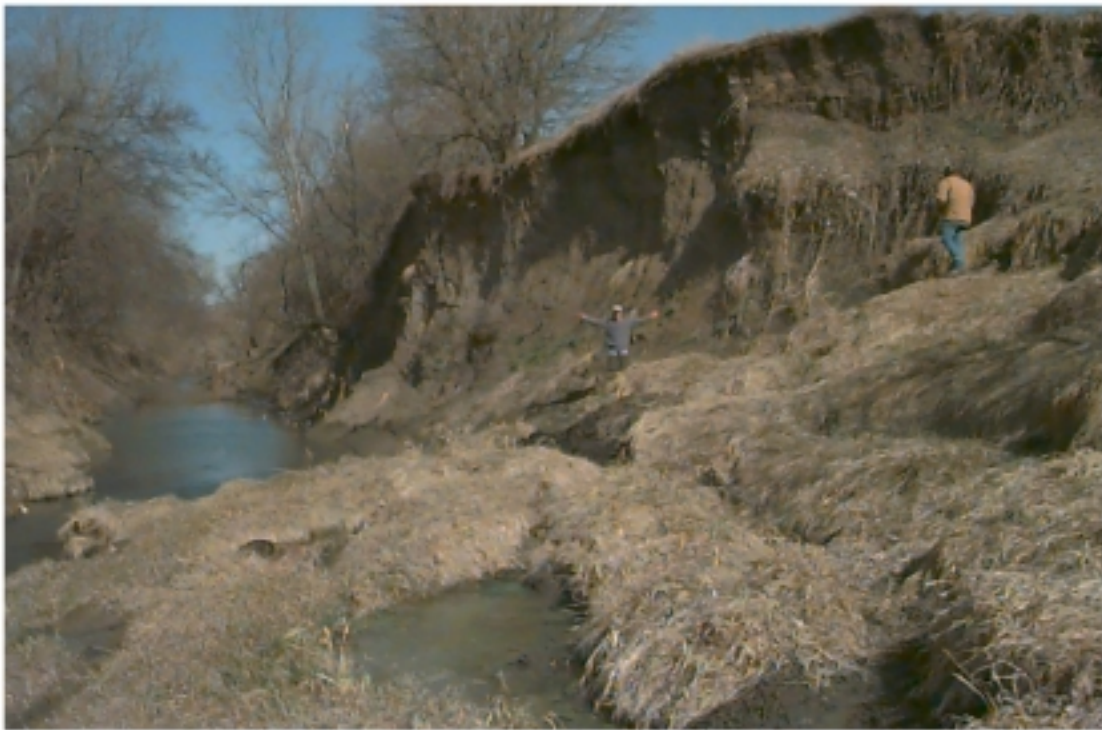
Figure 1.6 Streambank failure along West Papillion Creek between Dodge and Pacific Streets.

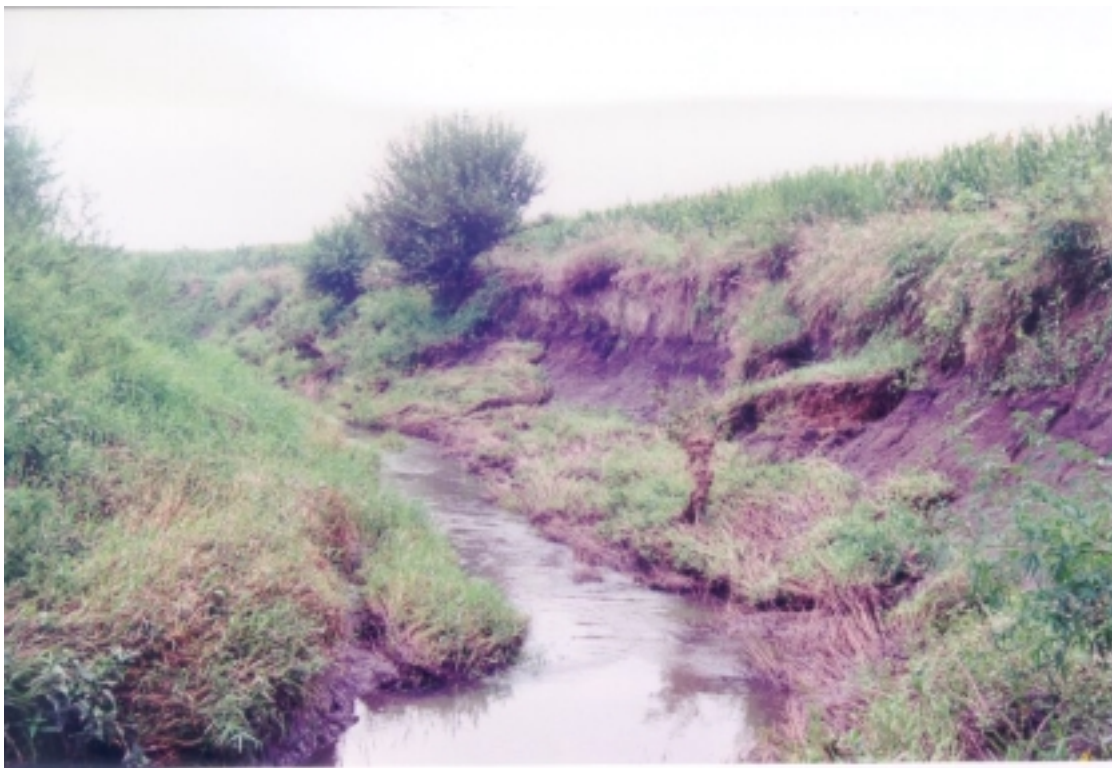
Figure 1.7 Streambank failure along North Branch West Papillion Creek north of Fort Street.

The West Papillion Creek is a tributary of the Big Papillion Creek and drains approximately 63 mi² (163 km²) just upstream of the confluence with South Papillion Creek and Hell Creek. The average channel slope along the modeling reach is 0.0023. The West Papillion Creek has been severely impacted by urbanization. The channel has incised and widened significantly (Figures 1.5 and 1.6). Urbanization in the West Papillion Creek watershed is continuing north of Blondo and Maple Streets. It is expected that runoff will increase, leading to continuing incision and streambank failures along the North Branch West Papillion Creek (Figures 1.7 and 1.8).

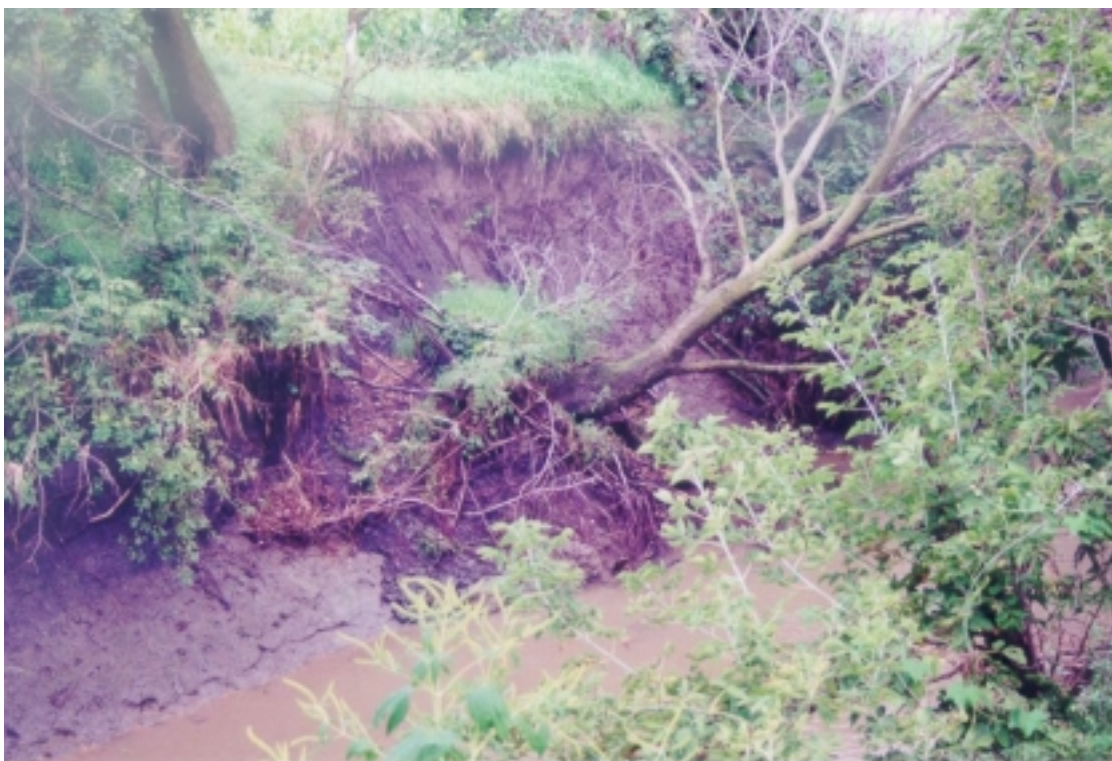
Figure 1.8 Streambank failure along North Branch West Papillion Creek downstream of Blondo Street.

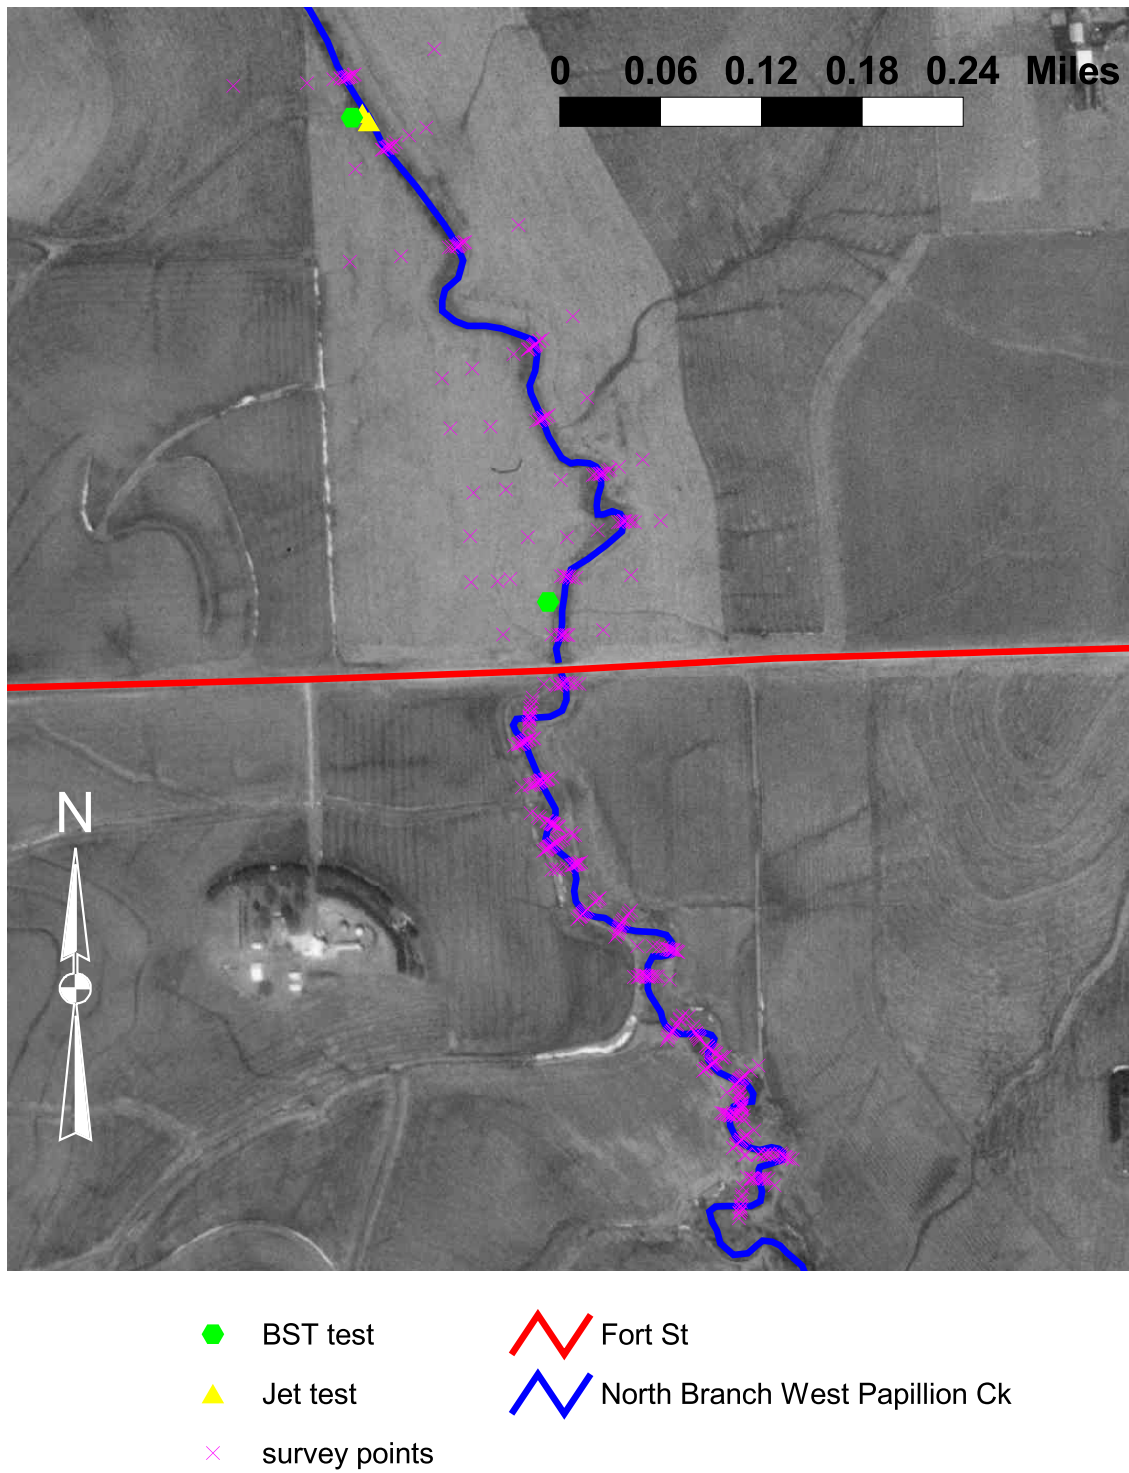
Figure 3.4 Data collection locations along North Branch West Papillion Creek near Fort Street.

Bulk density of the bank material was determined at these sites as well as sites where BST tests failed: upstream of Fort Street (Figure 3.4) and downstream of Blondo Street (Figure 3.5). Bulk densities varied from 1.92 slug/ft³ (0.99 g/cm³) to 3.36 slug/ft³ (1.73 g/cm³). The average bulk density is 2.81 slug/ft³ (1.45 g/cm³). Bank material composition was determined of samples collected upstream of Fort Street and downstream of Blondo Street. Table 3.3 lists the shear-strength parameters of the bank material measured with the BST. Table 3.4 lists the composition of the bank-material samples.

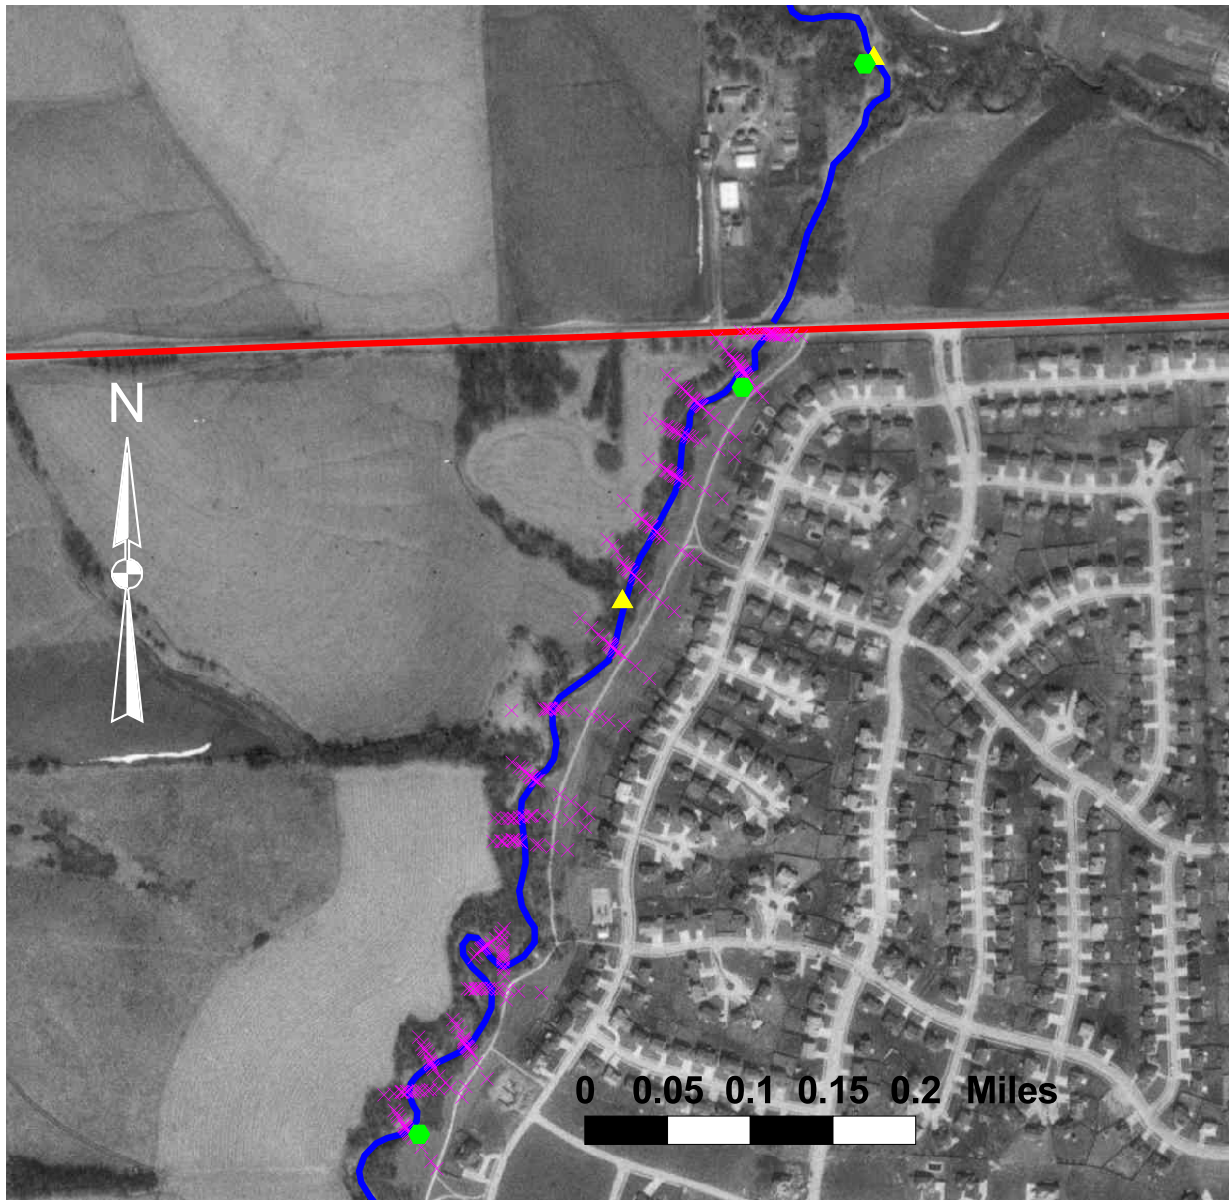
- ◆ BST test
- ▲ jet test
- × survey point
- Blondo St
- North Branch West Papillion Ck

Figure 3.5 Data collection points along North Branch West Papillion Creek near Blondo Street.

The following reaches along the North Branch West Papillion Creek and West Papillion Creek were surveyed: (1) 21 cross sections downstream of Fort Street (September 11, 1997, Figure 3.4); (2) 9 cross sections upstream of Fort Street (November 19, 1997, Figure 3.4), which were resurveyed on October 20, 1998 to obtain a more detailed profile of the streambed; (3) 19 cross sections downstream of Blondo Street (September 12, 1997, Figure 3.5); (4) 4 cross sections upstream of West Center Street (November 25, 1997, Figure 3.7); (5) 6 cross sections near North 168th Street (March 17-18, 1999, Figure 3.6); (6) 2 cross sections upstream of Blondo Street (March 18, 1999, Figure 3.5); and (7) 2 cross sections downstream of Dodge Street (March 19, 1997, Figure 3.7).

Jet tests were performed: (1) downstream of Blondo Street (November 5, 1997, Figure 3.5); (2) upstream of Fort Street (November 6-7, 1997, Figure 3.4); (3) downstream of 168th Street (March 17, 1999, Figure 3.6); (4) upstream of Blondo Street (March 18, 1999, Figure 3.5); and (5) downstream of Dodge Street (March 19, 1999, Figure 3.7). Bed material samples were collected at the 1997 test sites (downstream of Blondo Street and upstream of Fort Street). Table 3.1 lists the results of the jet tests. Table 3.2 lists the composition of the bed material samples.

Successful BST test were carried out downstream of 168th Street on March 17, 1999 (see Figure 3.6 for their location), upstream of Blondo Street on March 18, 1999 (Figure 3.5), and downstream of Dodge Street on March 19, 1999 (Figure 3.7).

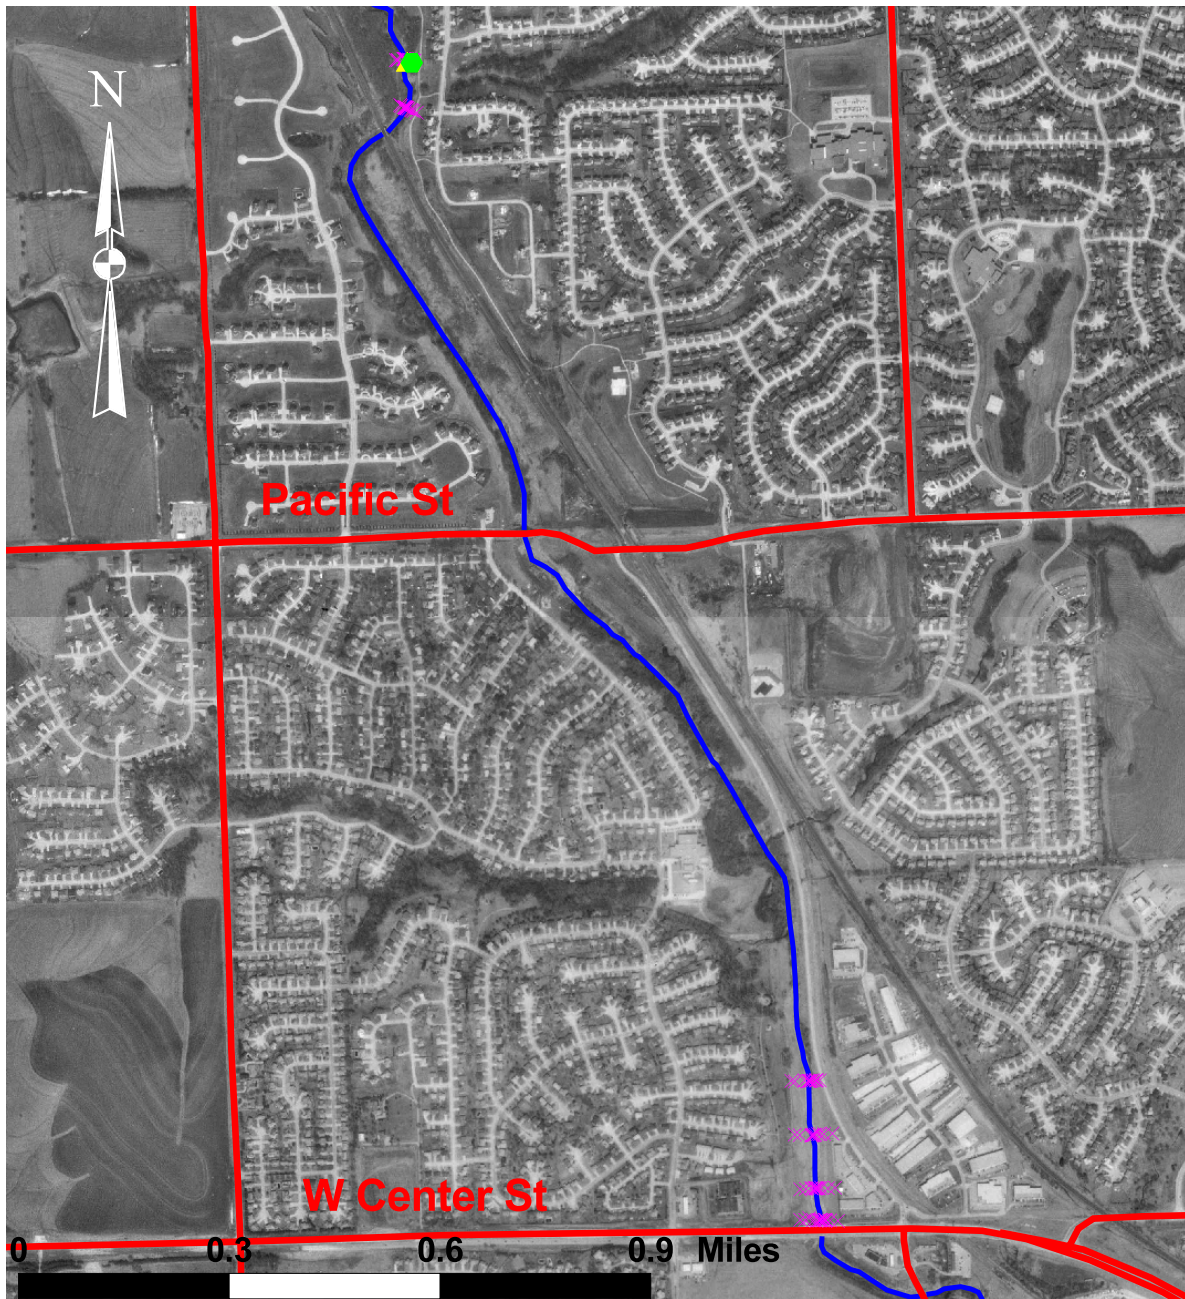
- ◆ BST test
- ▲ jet test
- × survey points
- roads
- West Papillion Creek

Figure 3.7 Data collection locations along West Papillion Creek between Dodge Street and West Center Street.

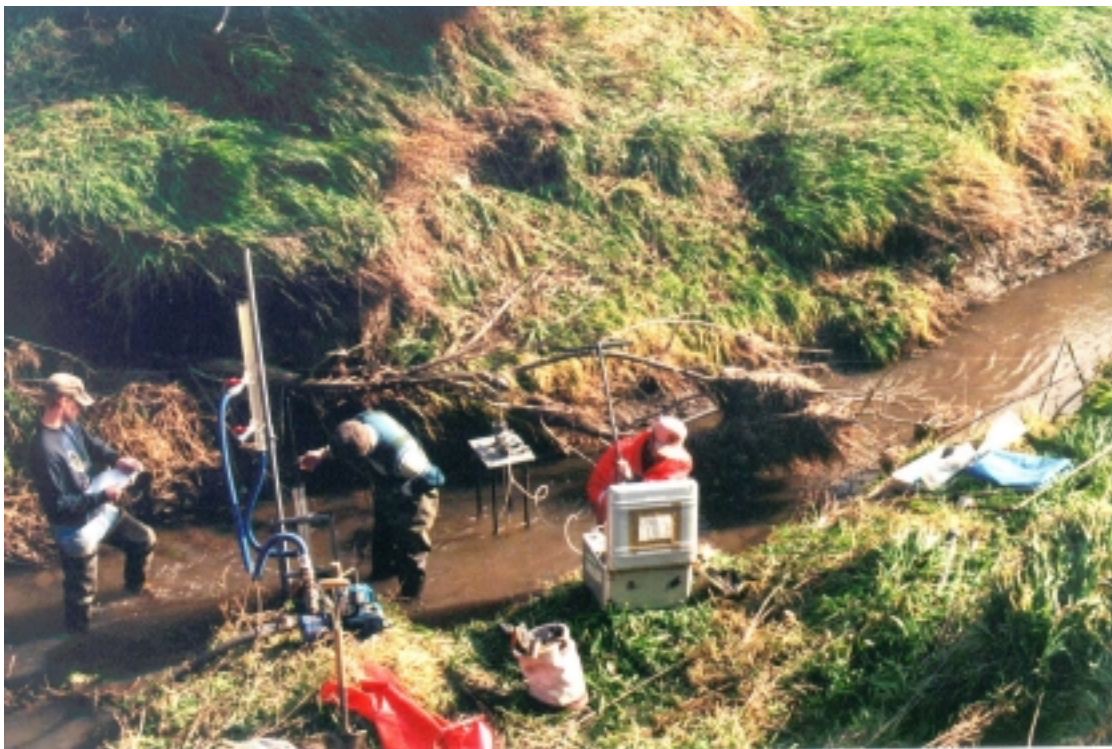
Figure 3.10 Submersible jet device at left and borehole shear test device at center.

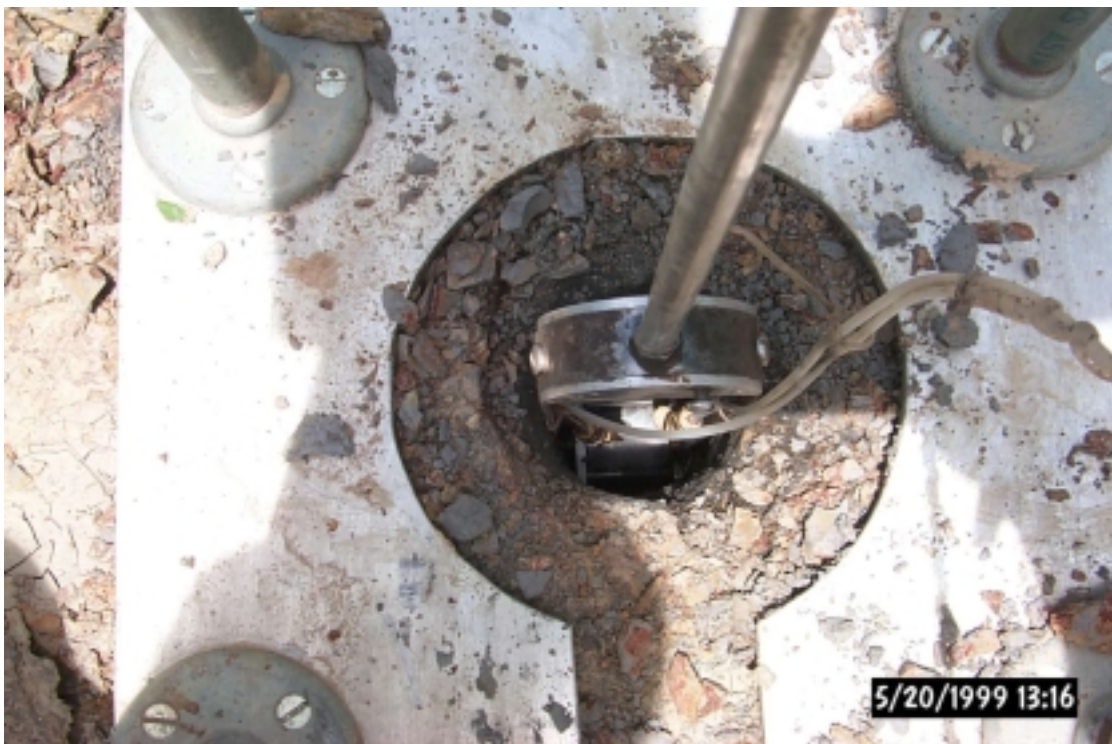
Figure 3.11 Borehole shear test device being lowered into the borehole.
